Task Force Operations: An Overview

BY RAY DOWNEY

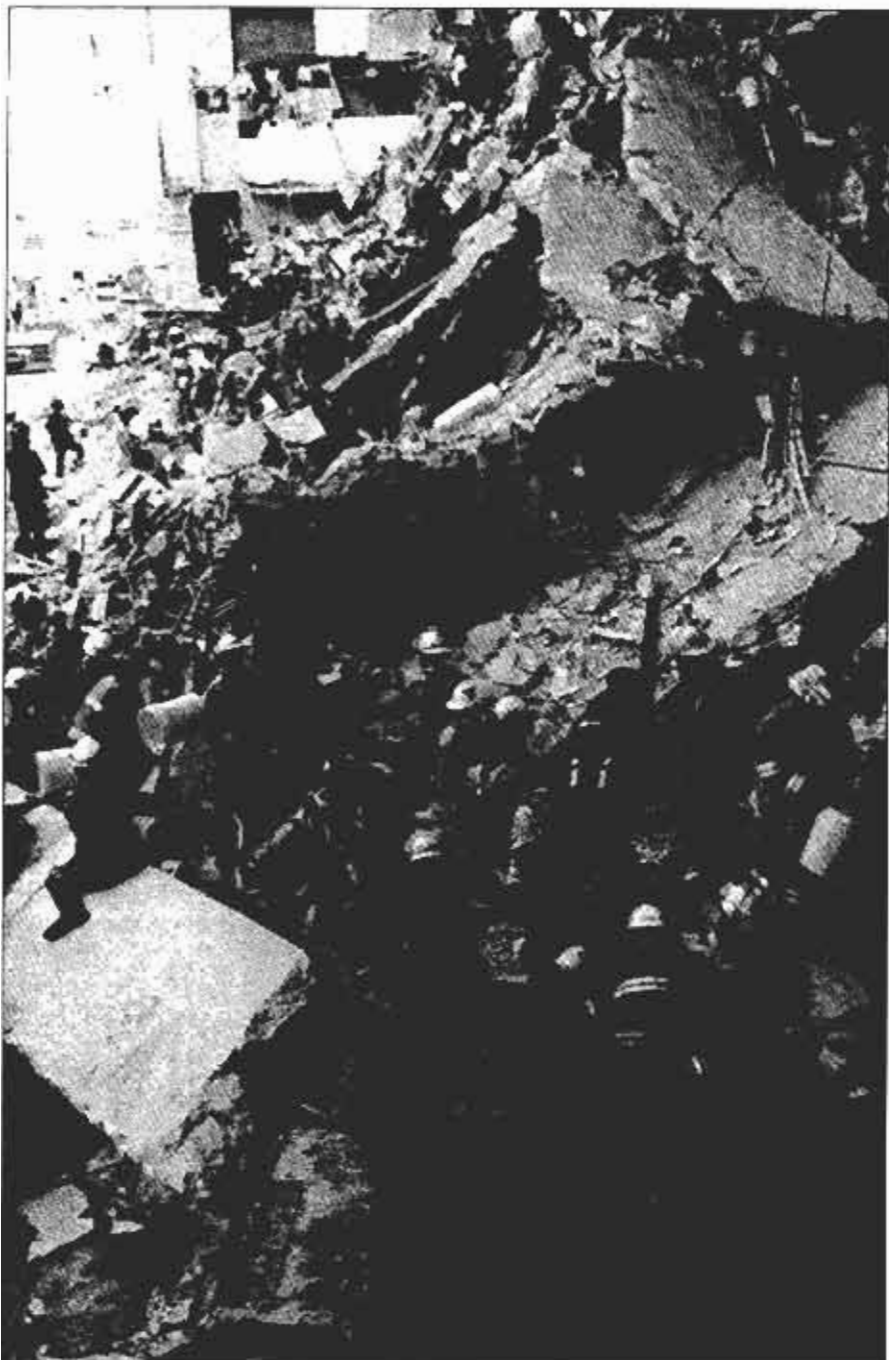
"Ants on the hill." Rescuers work on the 30-foot-high level of debris. (Photo courtesy of Oklahoma City Fire Department.)

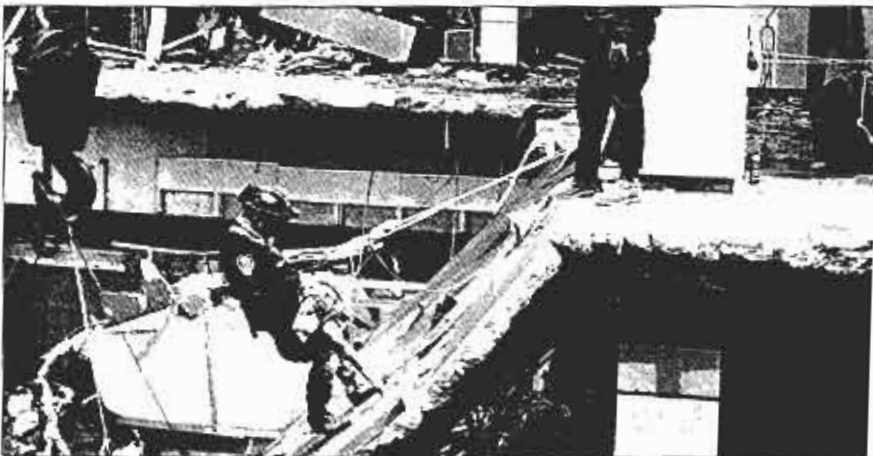
Cutting operation on a fallen slab. All operations were performed within the strictest margins of personnel safety possible.

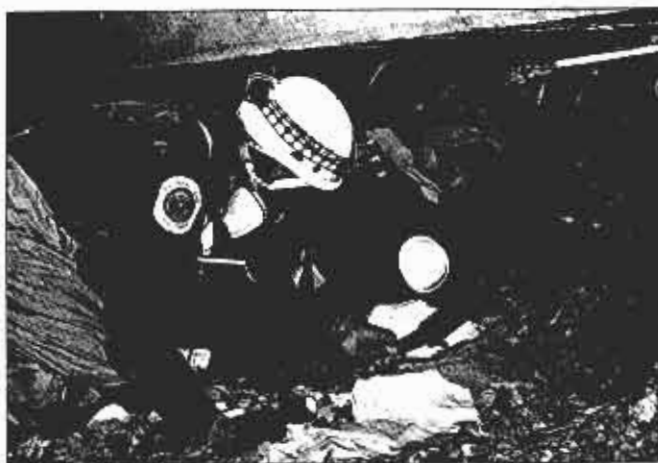
Firefighters operated search cameras in small void openings to identify victims.

had previously attended USAR training courses for search and rescue tactics. Technical search specialists using electronic acoustic/seismic listening devices and video search cameras worked with the canines and handlers. Once the canine alerted, a small opening was made in the debris for the device. The search camera was a very effective tool for pinpointing trapped victims.

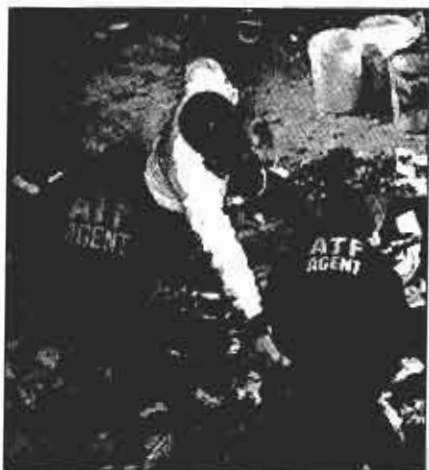
Every scrap of material was combed over by federal law enforcement agents. (Photo courtesy of Oklahoma City Fire Department.)
