BEWARE THE ROOF

BY RAY DOWNEY

COLLAPSE CAUSED BY THE BLIZZARD OF 1996

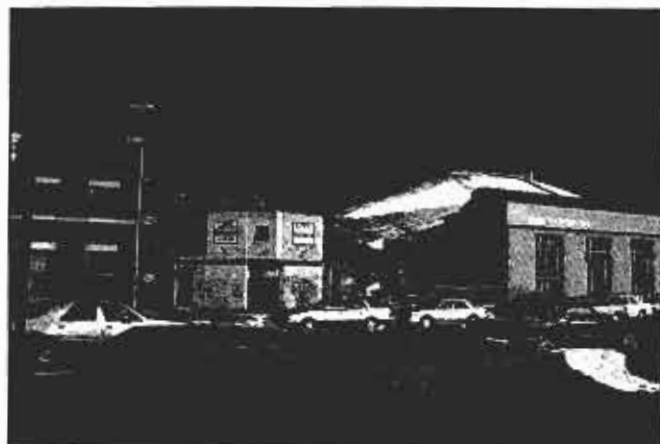
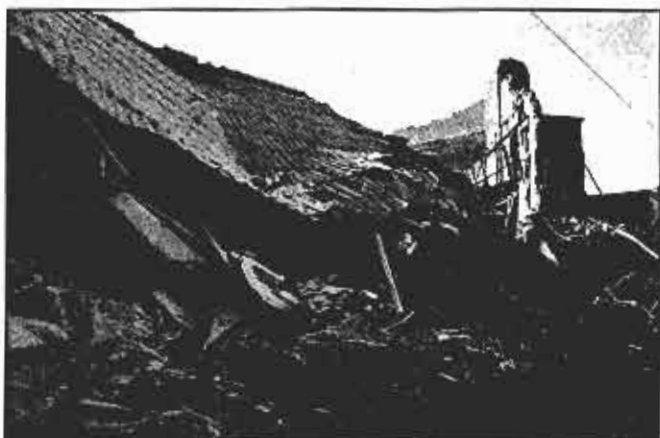
The snow load caused the collapse of each of these buildings. (Photos by John Norman.)
